Upstream of A35

CASE STUDY 5: ALLUM GREEN LAWN RESTORATION

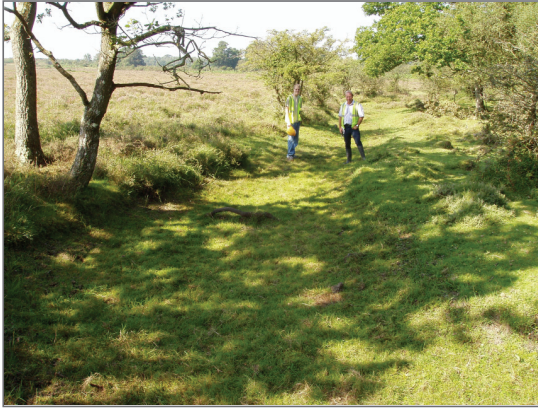
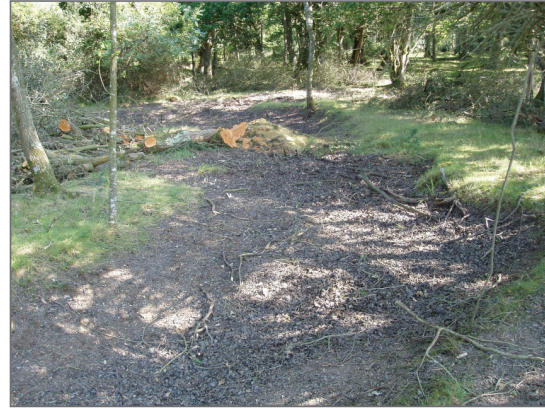
Palaeomeanders

- ◆ Excavation and reinstatement of former meandering channel. This required the felling of some willow and removal of organic material which had accumulated in the historic channel to reveal the original gravel substrate.
- ◆ Installation of a clay plug 20-30cm higher than the surrounding floodplain to divert the flow into the restored channel and prevent overtopping into straightened channel.

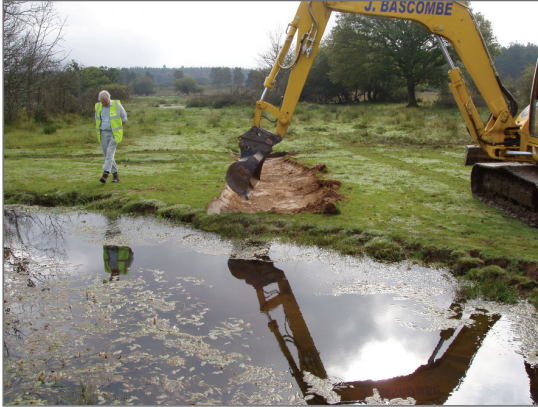
- ◆ Excavation of a short section of new channel (~10m long) to connect the flow to the lower floodplain.
- ◆ Removal of weed from a 350m length of channel to formalise one of the downstream channels.

Above left – excavating new reach to formalise flow into one main channel

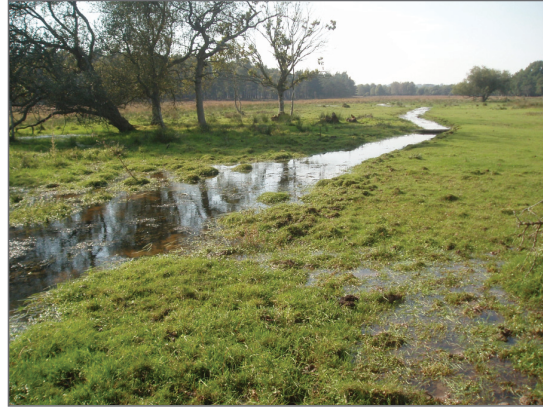
Above right – Completed Channel

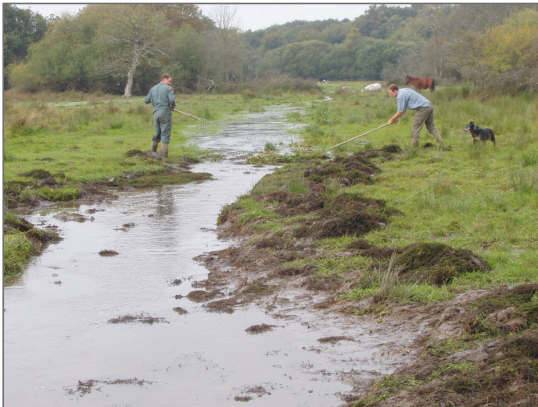
Left – weed clearance

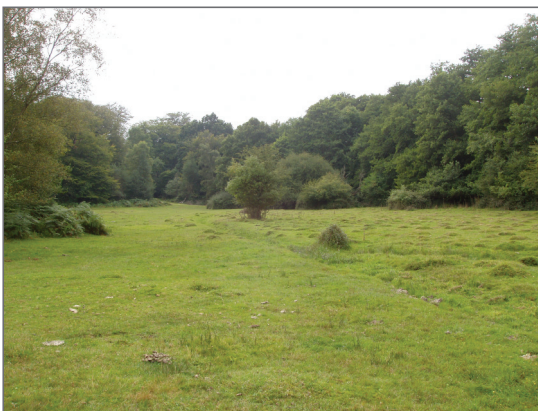
Allum green 2005
Area 3

Prior to restoration works in 2005 the open grassland had been reduced to 12 hectares with wet grassland communities lost to emergent and maturing woodland communities.

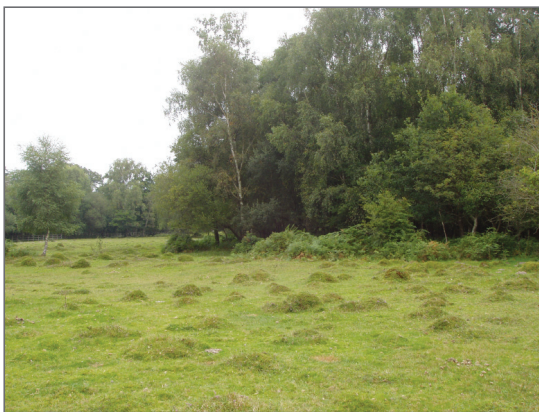
Before (Area 3)

Area 3 – Felling of young willow, birch and thorn to re-connect areas of grassland and mire. Felling of more mature trees at the woodland edge and removal of collapsed trees from open lawn areas. Infilling of drainage channel with material from remnant spoil banks.
